Nonlinear dynamic tests of a reinforced concrete frame building at different damage levels

Published in *Earthquake Engineering Structural Dynamics* **49** (2020), pp 924–945.

This paper discusses the dynamic tests of a two-story infilled reinforced concrete (RC) frame building using an eccentric-mass shaker. The building, located in El Centro, CA, was substantially damaged prior to the tests due to the seismic activity in the area. During the testing sequence, five infill walls were removed to introduce additional damage states and to investigate the changes in the dynamic properties and the nonlinear response of the building to the induced excitations. The accelerations and displacements of the structure under the forced and ambient vibrations were recorded through an array of sensors, while LIDAR scans were obtained to document the damage. The test data provide insight into the nonlinear response of an actual building and the change of its resonant frequencies and operational shapes due to varying damage levels and changes of the excitation amplitude, frequency, and orientation.

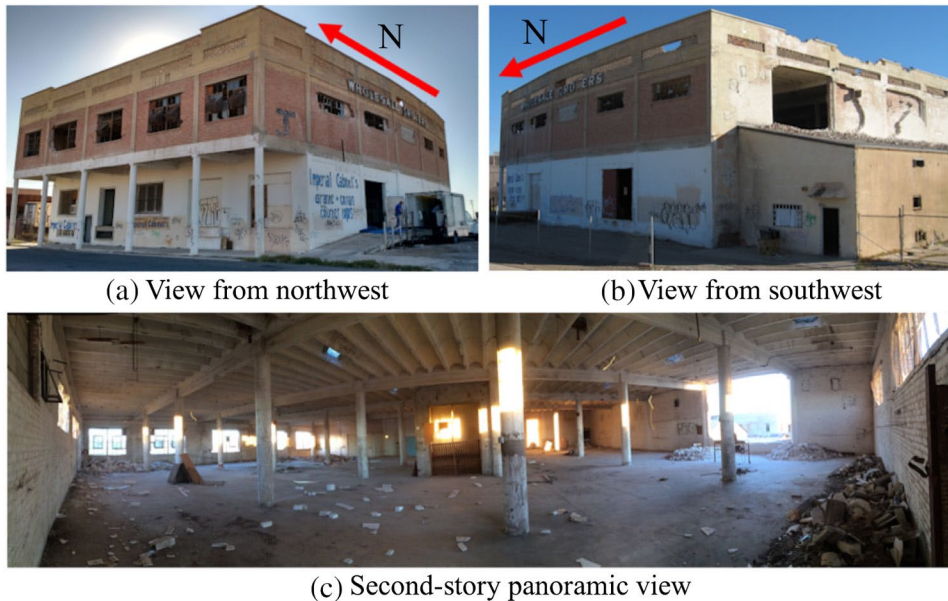
The two-story warehouse shown in **Figure 1** was built in the 1920s in El Centro, CA, and it was typical of the construction practice in California in that era. In plan, the building was 27.0 by 32.3 m (88.6 by 106.0

Figure 1 Test structure (prior to the tests)

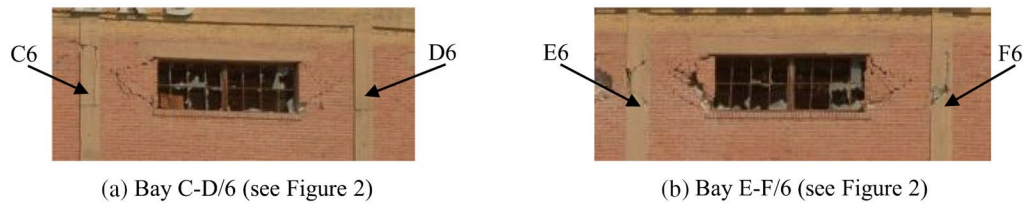
During the 2010 Baja El Mayor Cucapah earthquake, the structure was severely damaged and scheduled to be demolished after the completion of the tests as it could not be repaired cost-effectively. The damage concentrated in the second story infills and RC columns along the north, west, and south sides. Those along the east side of the second story and the entire first story did not develop any visible damage. **Figure 3** illustrates examples of observed damage that led to the evacuation of the building. The damage was quantified with LIDAR scans obtained before

**Figure 3** Damage in the columns and masonry infills along the west side of the structure in the second story

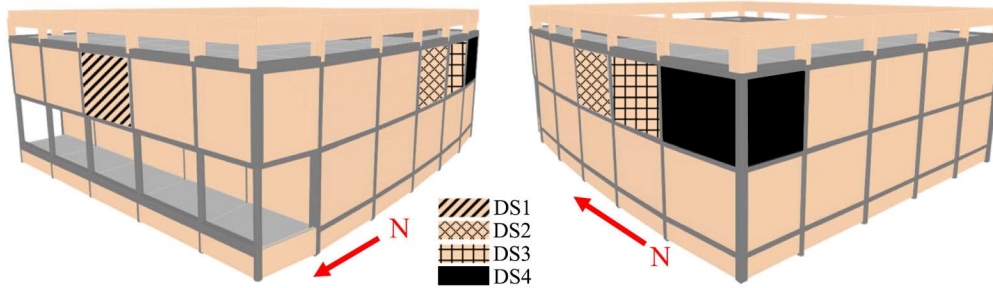
Figure 4 Damage states and wall removal sequence

system-identification techniques to capture the change of the dynamic properties. The initial damage state (DS0) was the result of the deterioration caused by aging and the earthquake sequence discussed in a previous section. Damage state DS1 was introduced by the removal of the infill in bay A/3-4 in the north side of the second story. This wall was removed prior to the tests to allow the insertion of the shaker inside the building. The second and third damage states (DS2 and DS3) were introduced by demolishing the infill walls in bays D-E/6 and E-F/6 in the west side of the second story, respectively. Finally, the fourth damage state (DS4) was introduced after the demolition of the infill panels in bays F-G/6 and G/5-6 in the second story, as shown in **Figure 4**.

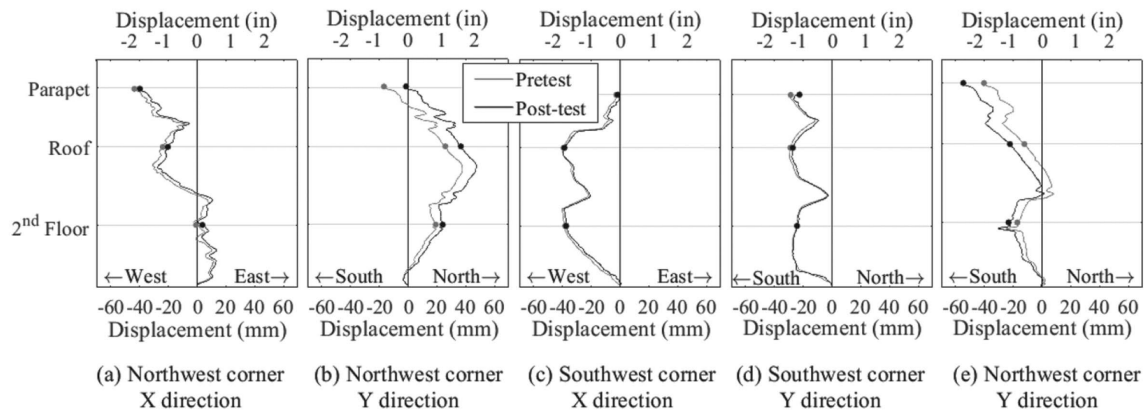
The deformation profile of the building and was also measured prior to and after the tests using the data obtained from the LIDAR scans. As discussed in a previous section, the measurement errors are estimated to be approximately one millimeter (0.04 in). Therefore, only deformations larger than the error are considered reliable. **Figure 21** illustrates the deformation profiles obtained at the corners of the structure. The profiles are shown for both the X and Y directions except for the southeast corner and the X direction at the northeast corner since no posttest data were obtained at these locations. From the plots, it is evident that the profiles are not smooth, probably due to surface roughness. Hence, they are not as informative for this level of structural deformations. However, the residual interstory drift ratio due to the tests is estimated for each floor level and reported in **Table 13**. The additional residual deformations at the northwest, southwest, and northeast corners were moderate, with maximum values of the induced interstory drift of 0.23%, 0.03%, and 0.22%, respectively, in the Y direction. The additional residual deformations in the X direction of the northwest and southwest corners

**Figure 21** Pretest (DS1) and posttest (DS4) deformation profiles (the positive directions are defined as north (Y+) and east (X+), respectively)
